## G - Analysis of chain damage

## Analysis of chain damage

### Causes and remedies

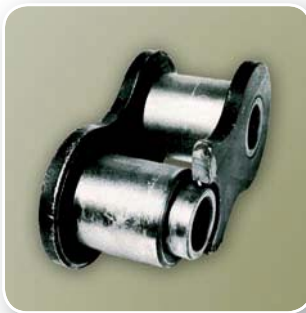
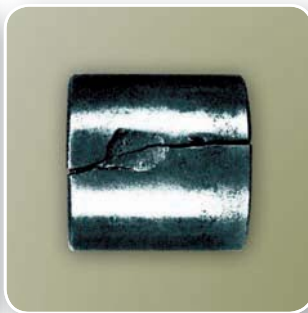
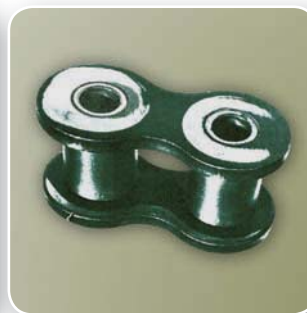
## Pin breakage from corrosion fatigue

When a load is applied to chain, the joint clearance accumulates between the "back side" of the pin and the inner wall of the chain link or bushing. The area of the pin thus exposed is susceptible to corrosive attack and pitting if it is unprotected and the chain operates in the presence of water, acid-base compounds, or materials that produce acids when combined with water.

Like any structural member, chain pins bend minutely under load. Under this condition, the surface on the back side of the pin is stretched, or put in tension. If the pin has been pitted by corrosive attack, each pit becomes a point of stress concentration.

The illustration above shows how bending can eventually cause fatigue cracks to start at the points of stress. These cracks can progress until the pin finally breaks during a load cycle.

A less advanced stage of corrosion pitting is illustrated at the bottom. Note the areas on the pins that were in contact with sidebars and thereby protected from attack.

The illustrations at the top show an advanced stage of corrosive attack and depict the entire process of corrosion fatigue-pitting, cracking and fracture. The pins shown were removed from a conveyor which handled an acid-producing material. In applications like this, it is sometimes possible to reduce the degree of corrosiveness or acidity, in addition to providing a protective coating for the pins.

Protective coatings, such as a water-resistant lubricant or cadmium plating, are often effective in preventing corrosive attack. When conditions are severe, corrosive-resistant materials such as stainless steel may be most effective.

To find the most effective deterrent to corrosion fatigue, all aspects of load, speed, material handled, etc., must be recognized and evaluated.

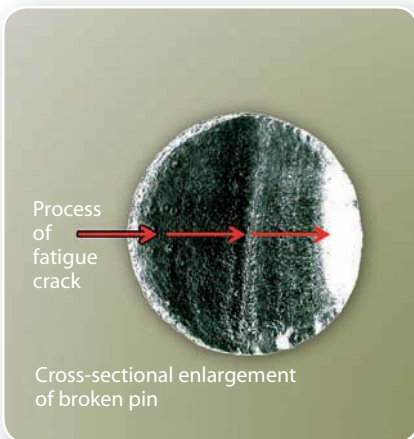
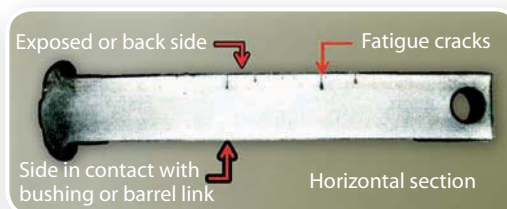
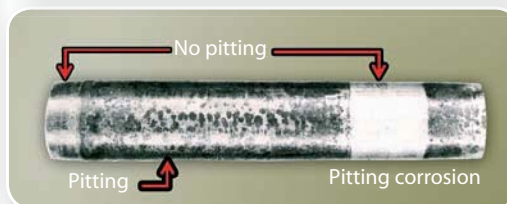
## Pin wear from abrasion, inadequate or ineffective lubrication

Wear is a normal condition that is expected whenever there is motion and contact between two parts, such as the articulation of a chain pin in a link barrel or bushing.

The presence of abrasives or an ineffective oil film between the bearing surfaces can result in an accelerated rate of wear. For example, the pin shown above was removed from a power transmission chain exposed to an atmosphere heavily laden with sand and dirt. These abrasives penetrated the chain joints, causing rapid pin wear, and a substantial reduction in the useful life of the chain.

Unusual pin wear is often the result of inadequate or ineffective lubrication. In these cases, the film of oil between the bearing surfaces is not sufficient to properly prevent metal-to-metal contact or flush the chain joint. As a result, the pin can be abraded in a manner similar to that shown in the photo. Rapid pin wear from this cause can usually be overcome by an improved method of lubrication.

Under conditions like this, periodic removal of the chain, through cleaning, and careful re-lubrication will usually prolong chain life. Sometimes, power transmission drive chains can be enclosed in a sheet-metal casing which not only offers protection from abrasives but, at the same time, provides a means for effective chain lubrication.

Baffles or shields can sometimes be employed to protect conveyor chains from direct exposure to abrasives. Some large conveyor chains can be equipped with lubricated pins (pins with pressure-lubrication fittings) so that abrasives can be flushed from the chain joints at regular intervals. At other times, it may be desirable to re-pin the chain, using hard-chrome plated pins for greater wear resistance.

A thorough analysis of conditions will often suggest the most practical and effective measure for reducing pin wear and increasing chain life.

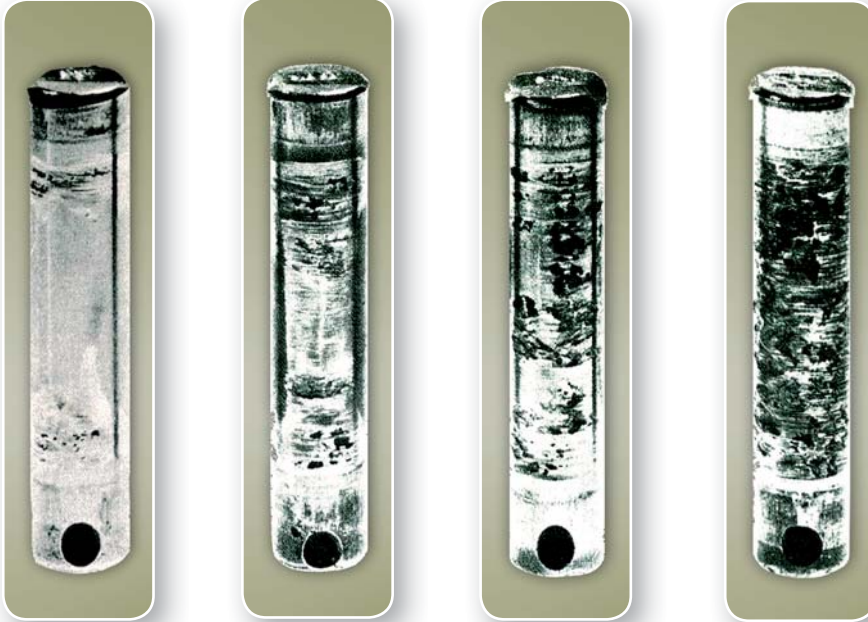
## Pin galling

INTENSITY OF GALLING

The primary purpose of lubrication (for chains or any mechanical device) is to provide an effective film of oil between bearing surfaces in order to prevent direct metal-to-metal contact.

Chain pins can become galled if the oil film is not adequate to support the load, or for some reason ceases to do so. The intensity of galling, of course, depends upon the degree and duration of the metal-to-metal contact.

Operation for very short periods under unusually severe load conditions, or very high speeds could cause incipient or moderate galling. This type of galling may not have an

More intense forms of galling may be observed when heavily loaded chains operate at either very high or very low speeds. At high speeds, pin galling could occur because of insufficient time between load cycles for an adequate film of oil to form. At very low speeds, high bearing pressures may squeeze the lubricant out of the joint and the sustained heavy load prevent it from re-forming between the bearing surfaces. Some change in load and/or speed will often permit the lubricant to function effectively thereby reducing the tendency of the pins to gall. In some situations, a more effective method of lubrication can be used.

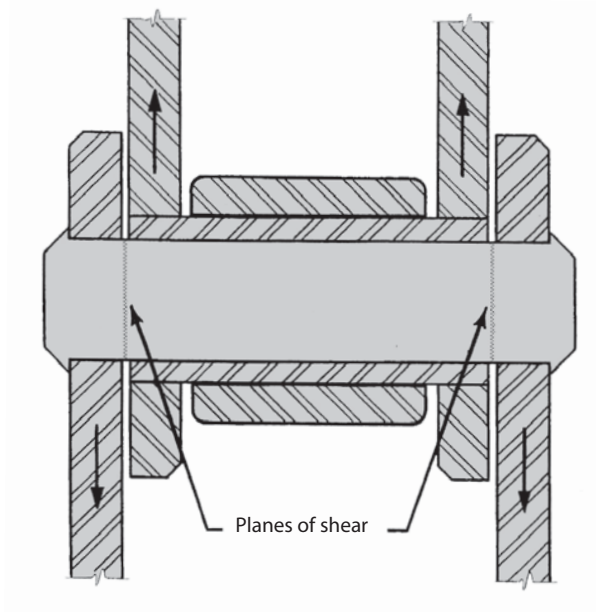
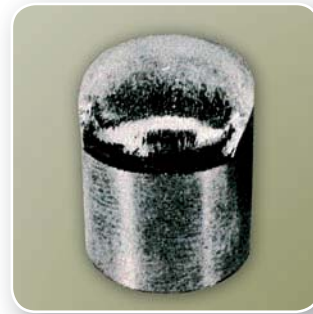
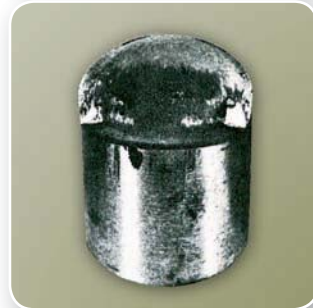
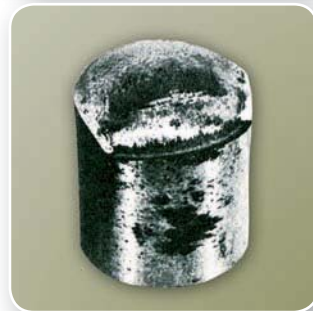
## Pin shear

On other pages we have noted that chain pins (depending on the situation) may: wear, break, gall, corrode, or bend. In other circumstances more rarely encountered, a chain pin may shear.

If pin shear occurs, it can usually be traced to a sudden, abnormally severe overload. Accidental jam-ups would be an expectable cause. In the case of the pins illustrated, a severe shock load was applied to an already heavily loaded drive, causing the pins to shear.

Pin shear is characterized by a rounded, reasonably smooth cross-sectional surface as shown in the photos at right. Shearing occurs at the points illustrated by the sketch above.

Since pin shear can be traced to an abnormal load condition, the cause can usually be determined. Precautionary measures can then be taken to avoid a recurrence.

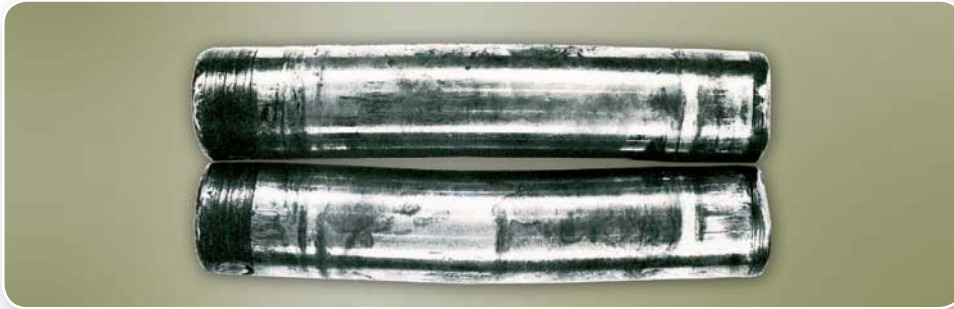
## Pin bending from overloading

Pin bending usually results from a sudden load application heavy enough to cause permanent deformation, but not heavy enough to shear the pin.

This condition has been seen when a drive chain has been operated beyond its design capacity. It has also been observed in heavily loaded conveyor chains where the addition of a sudden shock load exceeded the chains normal working capacity.

Bent pins result in a loss of chain pitch uniformity and pair joint articulation. These conditions can impose additional stresses on the chain and increase the rate of sprocket tooth wear. Consequently, in addition to correcting the cause of pin bending, it may be desirable to replace the bent pins or the entire chain.

In situations like this, corrective measures can often be taken to reduce either the severity of loading or the probability of overloads.

The pins of conveyor chains exposed to high temperatures may deform if heavy loads exist. This tendency can often be overcome by shielding the chain from direct exposure to the heat. Baffles are commonly used for this purpose. Under extreme conditions, a protective water jacket or a heat-resisting alloy chain can be used.

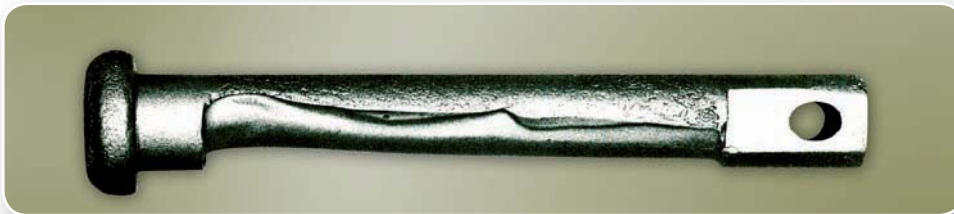
## Pin and bushing erosion

The erosion of chain joint bearing surfaces can occur when chains handle abrasive and corrosive materials in the presence of water. The degree and rate of erosion, of course, depend upon the severity of conditions and rarely reach the extreme stage illustrated above.

Erosion is a continuing process wherein the abrasive impurities and the water combine to literally wash away steel particles from the bearing surfaces. This eroding action gradually reduces the cross-sectional areas of the pins and bushings, as well as their load carrying capacity.

Some protective coatings can be effective in retarding corrosive attack and abrasive wear. In some cases, stainless

steel pins and bushings can be effective in combating erosion. Sometimes it may even be possible to reduce the degree of acidity, in addition to providing a protective coating for the joint parts.

A thorough evaluation of the effect of each factor contributing to erosion will indicate the most practical corrective measure for extending chain life.

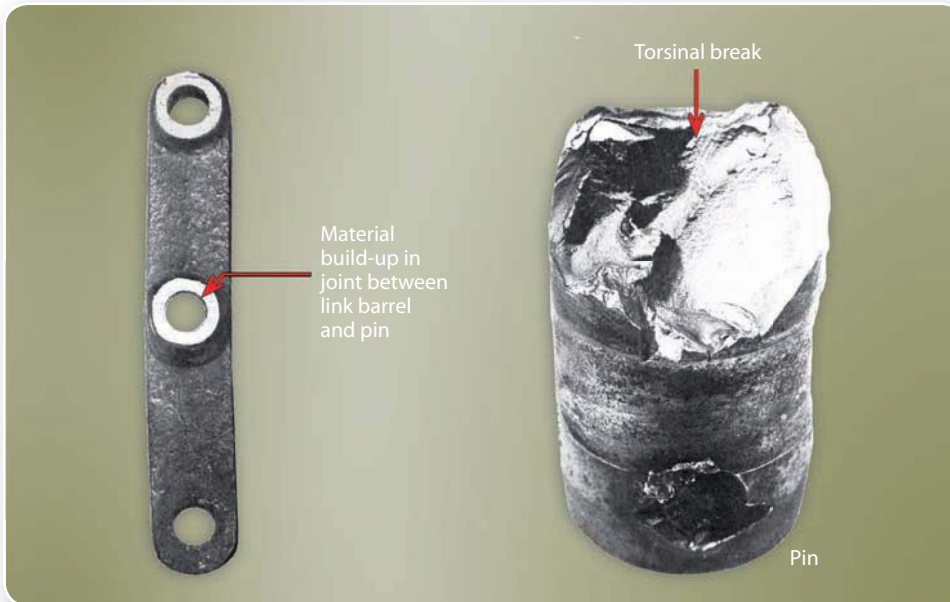
## Chain joint seizure

Chain joints are susceptible to freezing (or binding) if the bearing surfaces become severely corroded or galled, or if the clearances between the joint parts become packed with a material that tends to harden.

In moderate cases, the joint components may break loose when the chain articulates over the sprockets. In the event of a rigid joint seizure a torsional pin break could occur, or the sidebar pitch holes could tear.

A protective coating may be useful in preventing rust, and possible freezing, when chains are subject to intermittent operation or long periods of idleness. In these cases, occasional operation during idle periods will substantially reduce chances of binding.

Corrosion-resistant pins and bushings may be preferred in severe cases.

Similarly, a lubricant will often retard penetration of the joint clearances by materials which pack and harden. Some of the larger chains can be equipped with pins having pressure-lubrication fittings so that foreign materials can be flushed from the joints. In some other cases, the preferred method for prolonging chain life may be frequent removal, thorough cleaning, and careful re-lubrication.

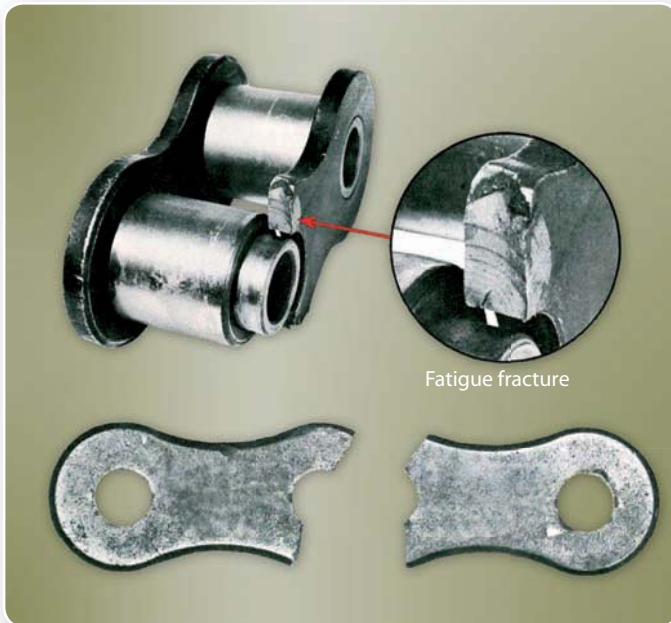
## Sidebar fatigue at pitch holes from severe cyclic loading

Sidebar fatigue occurs when the frequency and magnitude of stress-on, stress-off cyclic loading causes the sidebar material to reach the limit of its fatigue before the chain is worn out.

A sidebar fatigue failure begins with a very minute crack at the edge of a pitch hole. With repeated load cycles, the crack gradually progresses outward until the sidebar is sufficiently weakened to permit complete fracture.

Consequently, a fatigue failure is characterized by a series of concentric, curved lines in an area having the appearance of a brittle fracture.

Sometimes, it is possible to reduce the magnitude of chain loading; however, a thorough analysis of all operating conditions is usually required to find an effective solution.

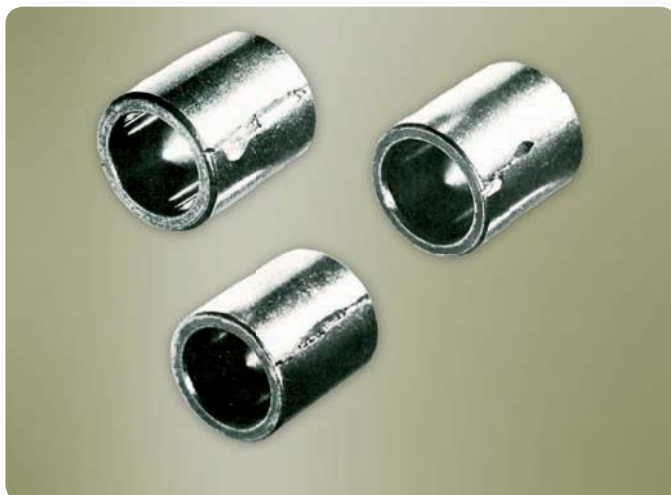
## Roller fatigue from corrosion, galling, or packing of joints

Impact of some magnitude takes place whenever chain rollers contact sprocket teeth. If operating conditions involve heavy loads and high speeds, the shock of tooth-meshing can be severe. Sometimes the impact is great enough to induce high stresses in the surfaces of the rollers. Under repeated heavy blows, these stresses could cause fatigue cracks to start.

Ultimately, the rollers could break due to metal fatigue.

Roller fatigue can often be overcome by a reduction in load and/or speed.

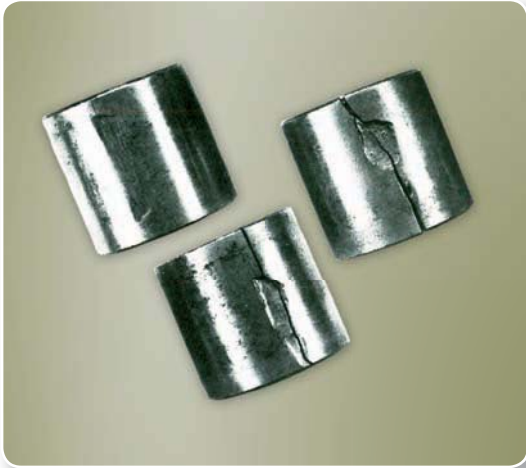
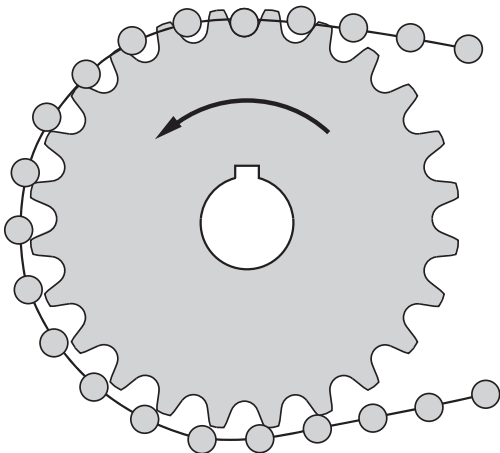
## Crushed rollers or bushings from high load concentration

Due to pitch elongation, a severely worn chain may not seat properly on its sprockets. As illustrated in the above figure, some of the rollers (or bushings) may contact the tips of the sprocket teeth. This can impose loads large enough to crush the rollers or bushings. When this type of engagement is observed, the chain should be replaced to prevent undue sprocket damage.

Improper engagement can similarly occur when a new chain is operated on severely worn sprockets. Rollers can be crushed in the same manner as described above. Severely worn sprockets should be replaced at the same time as the chain if full service life is to be received.

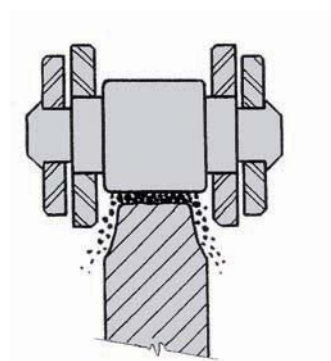
**Sprockets with mud relief grooves**

Rollers can also be crushed if rocks or other hard materials build up or become trapped in the gaps between sprocket teeth. When chains operate in or near mud, rocks, etc., mud relief sprockets can often be used to protect the rollers from severe pressure and damage. The reliefs, located below and on each side of the tooth pockets, provide a means of escape for foreign objects so that they can be ejected by the rollers as they seat on the sprocket.

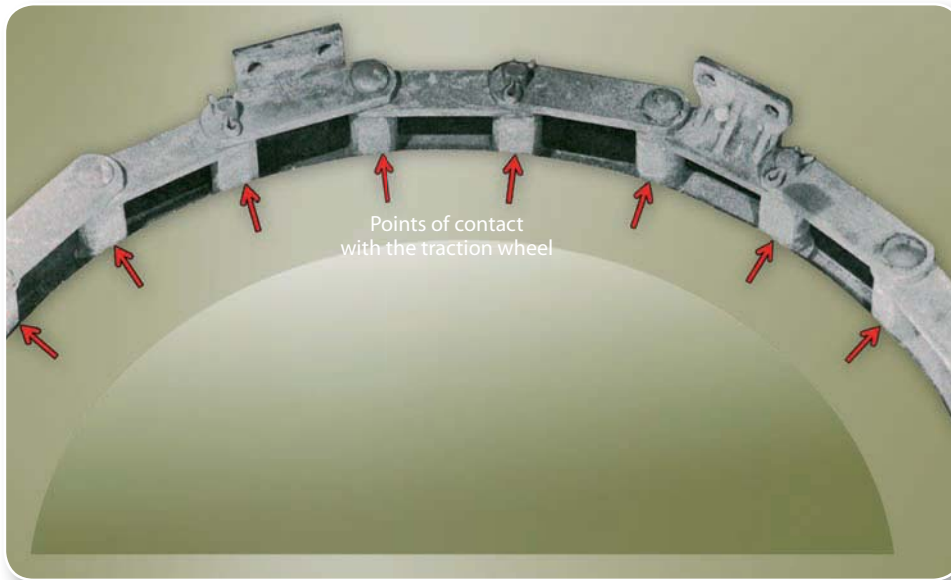
## Link wear

For bucket elevators and other applications, lower cost traction wheels can often be used instead of sprockets. However, adequate tractive force between chain and drive wheel is essential for efficient operation.

The chain link shown above was used in a bucket elevator handling a hard, abrasive material. The severe wear shown on this link was caused by slippage during periods of peak loading. At these times, the tractive force was not sufficient to drive the chain efficiently.

Surge loads could be expected to cause slippage between chain and traction wheels. Chain slippage in a bucket elevator can often be corrected by a more uniform, closely regulated feed. Care should be taken to maintain proper takeup adjustment, and to avoid overloading the chain with takeup tension. Sometimes, slippage can best be corrected by replacing the traction wheels by sprockets, thereby providing a means of positive engagement with the chain.

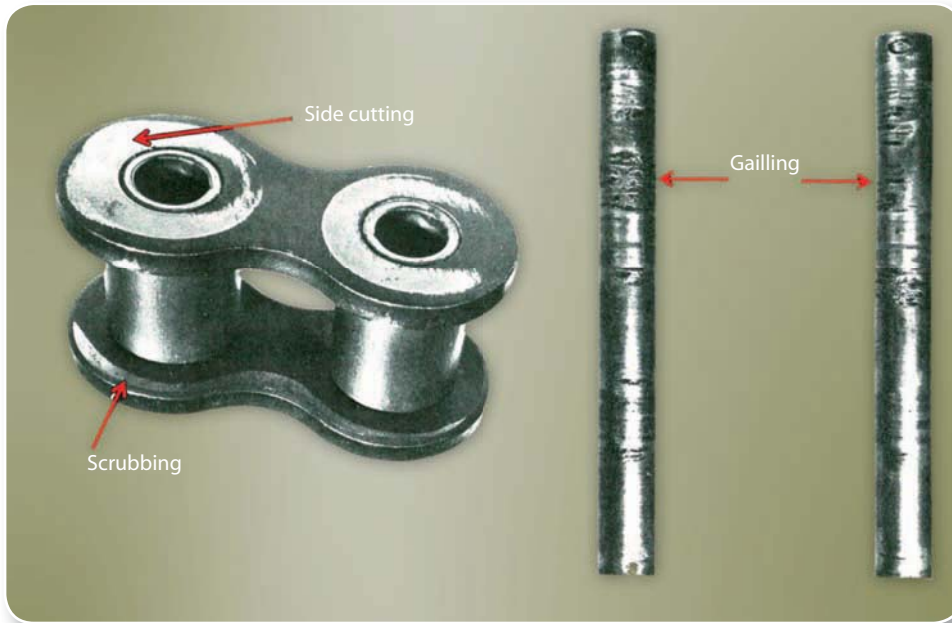
## Abnormal chain, sprocket, or track wear from misalignment

Unusual wear patterns on chain often indicate a condition of misalignment which can cause severe chain damage. The most common types of misalignment are:

Under some conditions of misalignment, one side of the chain is overloaded: under other conditions, the chain is forced to twist or distort as it moves from one sprocket to another.

Unequal chain loading can cause pin galling, sidebar failure, or rapid wear. The photo above vividly illustrates galling as a result of misalignment. A perceptible increase can be seen in the severity of galling toward the end of the pins where the overload was greatest.

Misalignment can also cause scrubbing between sidebars, or between sidebars and sprocket teeth, as illustrated by the chain link photo above. This kind of action causes side cutting, increased frictional loads, and in some cases, the loss of proper fit between parts.

Misalignment conveyor tracks can produce unequal wear in the chain. The curvature (or camber) that results, induces a tendency in the chain to run toward one side of the track or trough. This can increase the frictional load and cause damage to the tracks and the pin ends.

The best precaution against chain damage from misalignment is frequent inspection of drives and conveyors. Prompt adjustments can then be made when signs of unusual wear are observed.

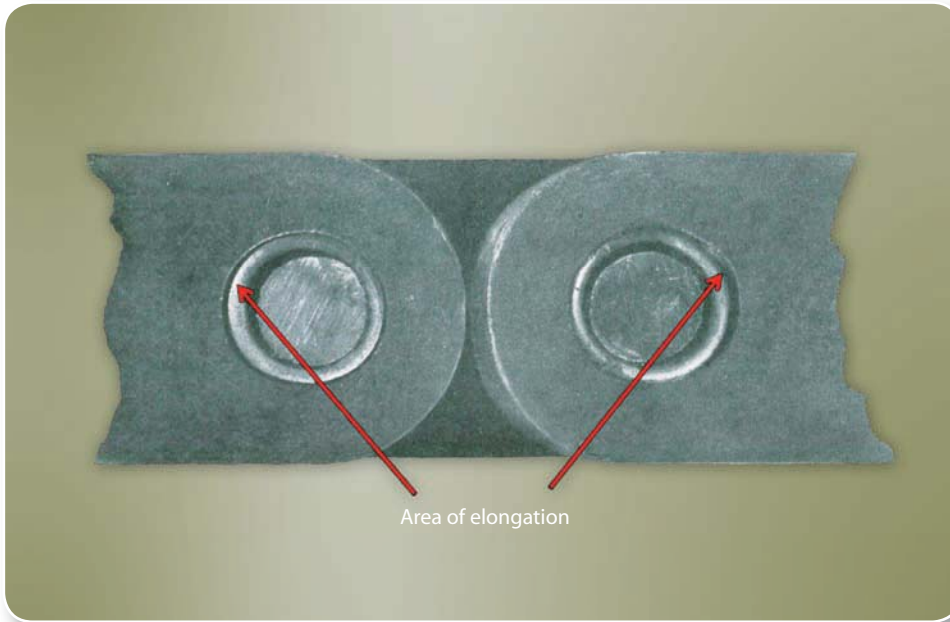
## Chain elongation (or stretch) from tensile overloads

This type of elongation involves plastic deformation wherein the sidebar material has been loaded beyond its yield point, but not beyond its ultimate strength. Consequently, the sidebars are permanently stretched, but do not fracture.

If pitch elongation is severe, the chain will no longer mesh properly with the sprockets. Quite often, too, an excessive tensile load will cause other damage, such as cracked bushings, crushed rollers, bent pins, or loss of fit between parts, which can lead to premature failures.

Chain elongation from tensile overload may result when equipment is forced to operate beyond its design capacity, when accidental jam-ups occur, and similar causes. The effect of this type of overload is illustrated above.

Corrective measures can often be employed to prevent the recurrence of overload. Sometimes a shock-absorbing device can be used so that overloads will not be transmitted to the chain.
